TECHNOLOGY DEVELOPMENT REPORT-MODEL 301 HLH/ATC CARGO HANDLING SYSTEM COUPLING

W. Nutley

Boeing Vertol Company

January 1974

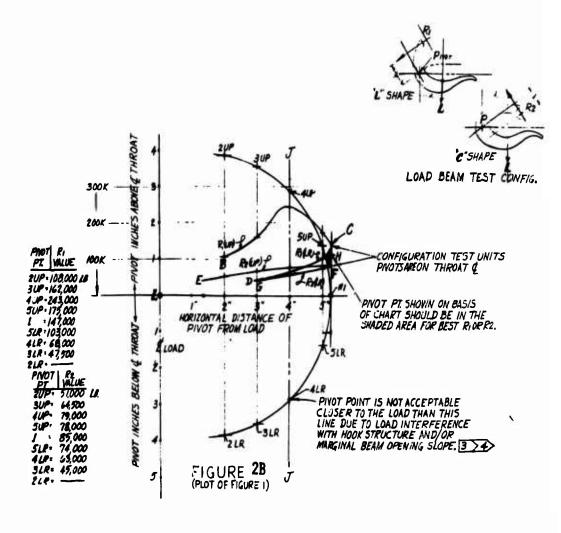
Figure 2. HLH Load Beam Configuration Study (SK301-10250, Sheet 1 of 3).

Figure 2 is an overlay of the throat configuration per requirement of the Reference 1 drawing. Point A is the back of the load beam throat contour, Point L is the center of the load or center of the load beam, and Point P is the pivot point.

Line J-J defines the boundary of acceptability of the pivot point location. The area to the left of J-J denotes pivot point locations which will cause the system to malfunction. Either the hook will not open at all or the load sling will not slide off the load beam. The latter will happen if the opening angle is too small for the load weight to overcome the friction. Experience on the CH-47 helicopter has indicated that the load beam slope should be greater than 17-20 degrees from the horizontal centerline for the fabric sling to slide on the metal load beam.

To provide reliability of operation, and minimal size and magnitude of reaction, the optimum pivot point (location H) should therefore be in the shaded area between C and F.

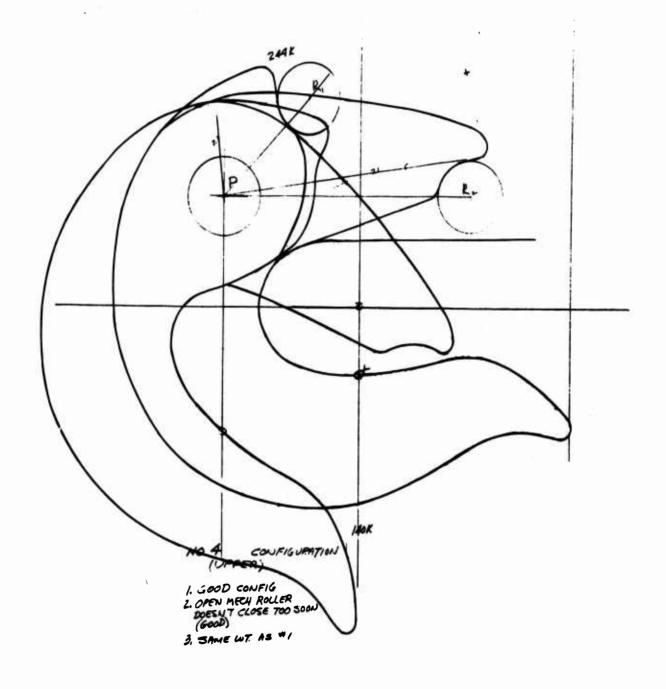
Figure 3. HLH Load Beam Configuration Study (SK301-10250, Sheet 2 of 3).

Figures 3 and 4 show both the L shape and the C shape, respectively, with the pivot point in several different locations. Configurations marked "upper" indicate that the pivot point is above the throat centerline. Those marked "lower" indicate that the pivot point is below the throat centerline. R1 and R2 are the reactions on the "L" and "C" shapes, respectively.

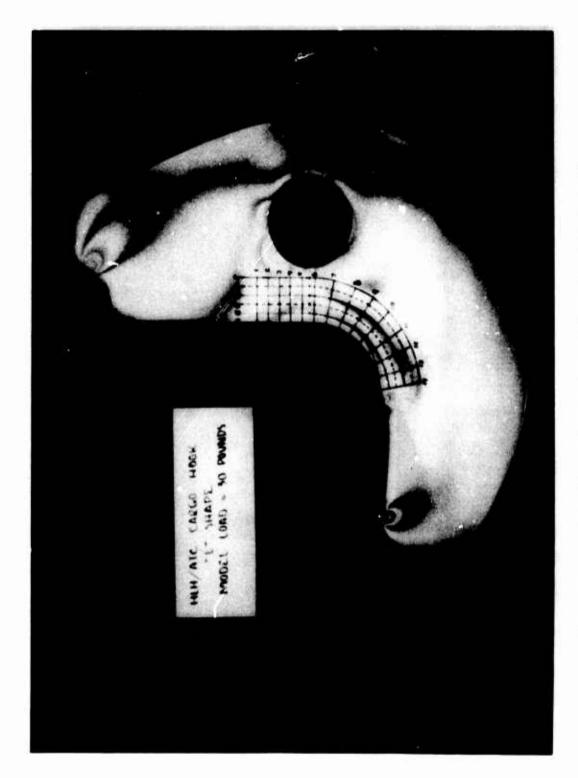
Figure 6. "L" Shaped Coupler Under 30-Pound Load.

A grid was drawn on each model to provide points for taking data. Lines were drawn at .20-inch intervals parallel to the inner contour to a distance 1 inch inboard of the contour (see Figures 6 and 7). Lines were then drawn radially from and perpendicular to the edge of the contour and spaced at approximately .30 inch apart. Photoelastic measurements, in fringe orders, were taken at each point as shown in Tables I and II. From this data, stress intensity curves were plotted to show stress levels at various points around the contour

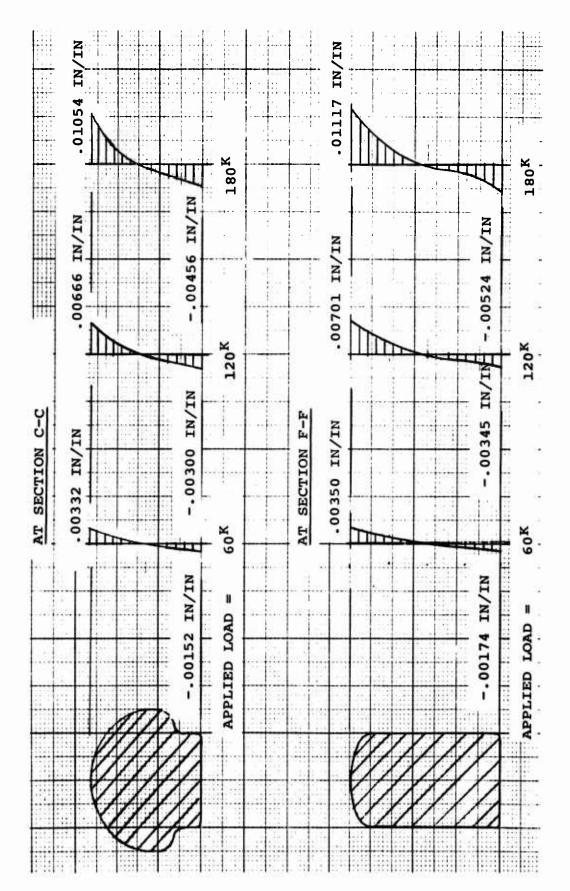
Figure 15. Section C-C.

The load beam configuration is depicted on Reference 3. Reference 1 defines the shape of the throat and also specifies that a cross section of the load beam in the throat area must be shaped with a 1.5-inch radius in order to minimize the wear with nylon-webbed slings. The cross section also had to be compatible with two 2.0- to 2.5-inch-diameter shackles. Figure 15 shows typical sections through the load beam in the throat area.

The strain distributions across Sections C-C and F-F (Figure 17) are shown in Figure 15. The interior (concave) surfaces of both sections show some plasticity, but failure at the trunnion prevented this effect from fully developing.

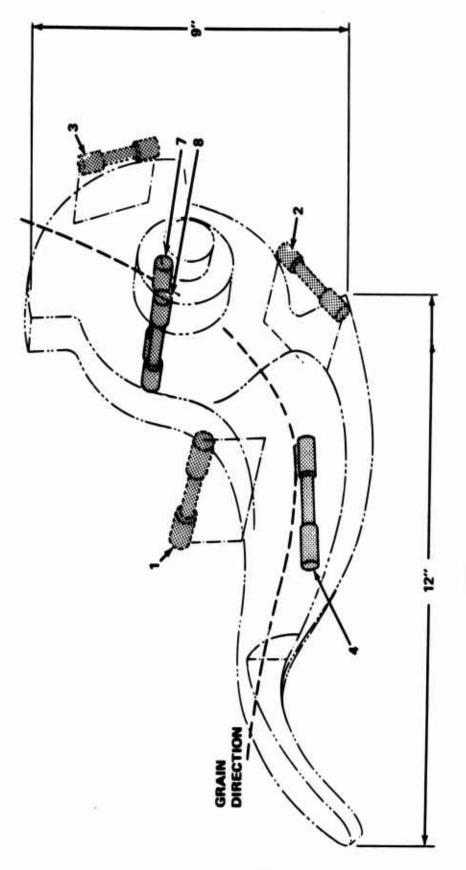
Figure 16. HLH Coupling Load Beam No. 1 and Tensile Specimens.

Test bars were sawn from the billet in accordance with Reference 4 (as shown in Figure 16). These pieces were machined to .252-inch diameter by Eastern Rotorcraft and aged with the rough machine load beam.

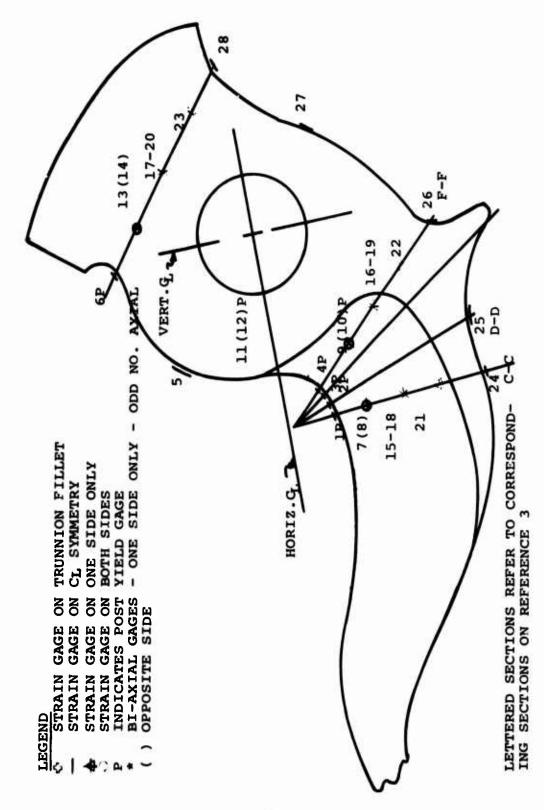
Figure 17. Strain Gage Location.

The gages were located as shown in Figure 17. Post yield gages were located in areas which were expected to be strained beyond the yield point. Gages were mounted symmetrically on both sides of the beam in several locations (7, 8, 9 and 10) so that unintentional lateral bending would be detected by comparison of the readings.

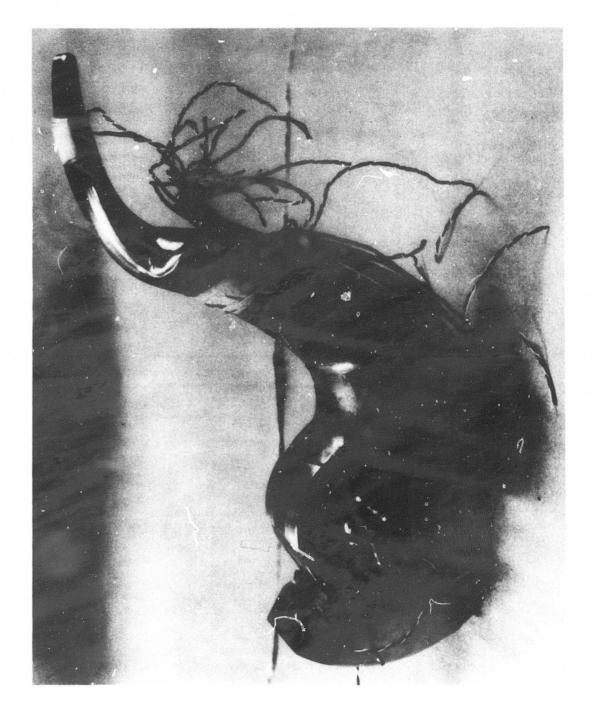
Figure 18. Load Beam Fractures.

The load beam fracture surfaces are shown in Figures 18, 19 and 20. The strain gage readings taken during the last run are listed in Table IV.

Boeing fracture analysis indicated a fracture origin in the trunnion fillet radius. All other cracks in the load beam were secondary to this point of initiation. This conclusion is substantiated by an examination of strain gage readings. Figure 27 shows that at a load magnitude of 180,000 pounds the strain gage readings increase from gage 1 to 2 to 3 and then start to decrease at gages 4 and 5. Fracture points A and B (Figure 27) between gages 4 and 5, and 5 and 6, respectively, are at lower stress levels than other surface areas and are therefore not the initial fracture points.

Destructive metallurgical examination revealed an ASTME 112 grain size of 1 to 2 at the fracture surface. Normal grain size expected for this corrosion-resistant steel is an average of No. 5. The large grain is detrimental to both notch tensile strength and fracture toughness.

It is also recommended that the stress concentration at the junction of the trunnion and load beam body be reduced and that a maximum acceptable grain size be stipulated on the drawing.

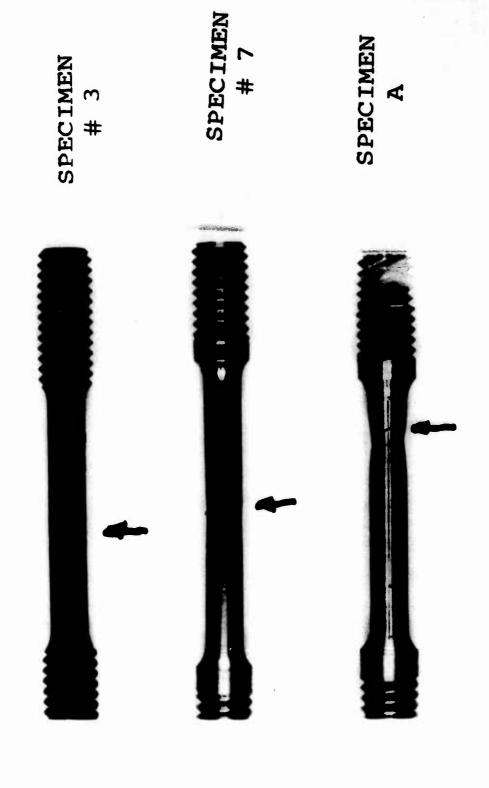
Figure 23. Necking Down at Failure.

The ductility of the load beam was therefore considerably less than expected. The amount of necking down at failure on Specimens 3 and 7 is compared visually with a dimensionally similar steel specimen (Specimen A) in Figure 23. Specimen A was cut from a 4340 steel forging with the following physical properties:

The points of fracture on all three specimens are indicated by arrows.

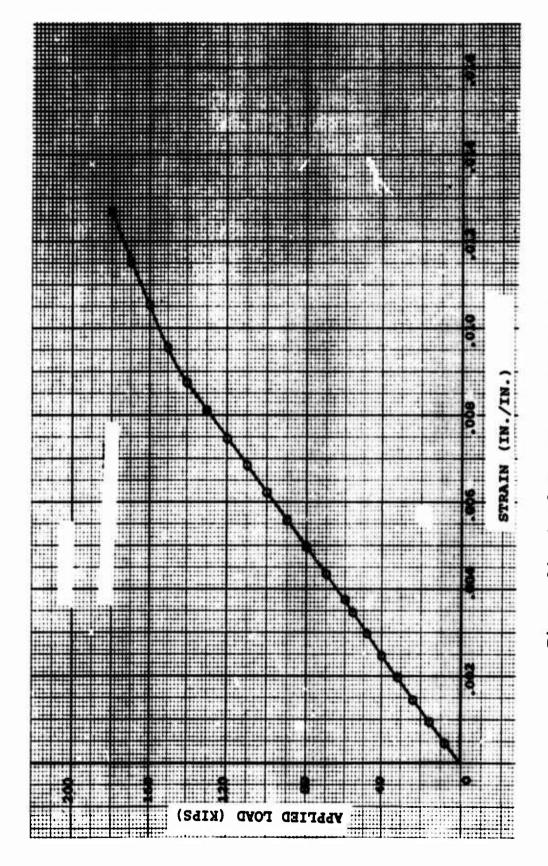
Figure 24. Loa 1 Versus Strain (Gage No. 3).

Plots of extreme fiber stress versus load are shown in Figures 24 to 26. None of the locations show a strain level which would be high enough to precipitate a failure in a normal ductile steel specimen; i.e., the maximum strain gage reading at any gage at an applied load of 180,000 pounds was .0127 in./in. (gage 3). This corresponds to an elongation of 1.27 percent.

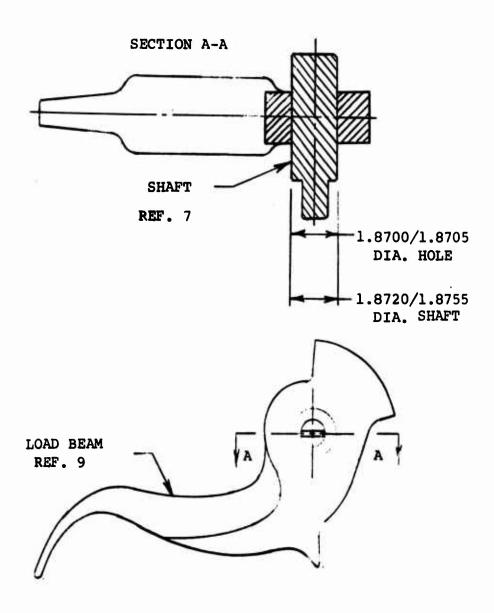
Figure 29. Load Beam Assembly - Second Ultimate Test.

Analytical work indicated that the basic section would be sufficiently strong with the center area removed, and it was therefore decided to make the trunnion a separate shaft as shown in Figure 29.

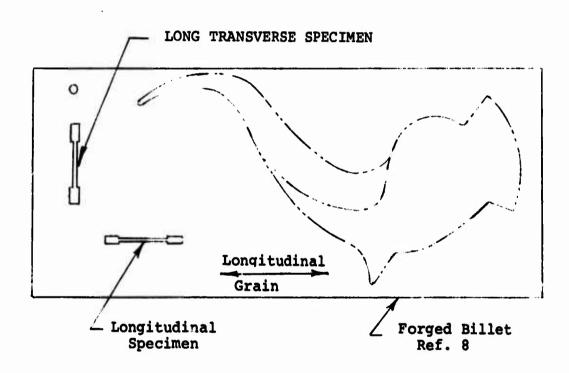
Figure 30. Location of Load Beam and Tensile Specimens in Forged Billet - Second Ultimate Test.

The beam was rough machined to within 1/8 inch of its finished contour and the shaft to within 1/32 inch of finished size. Both parts and the three tensile specimens shown in Figure 30 were solution heat treated to 1525°F ±25° and soaked for 2 hours after reaching this temperature and then rapidly force cooled in a nitrogen atmosphere to room temperature. They were then aged in air to 955°F +5° for 4 hours. The finished hardness was Rockwell C44 to C48. After a magnetic particle inspection, the load beam was finished machined to the dimensions of Reference 9 and the shaft to the dimensions of Reference 7.

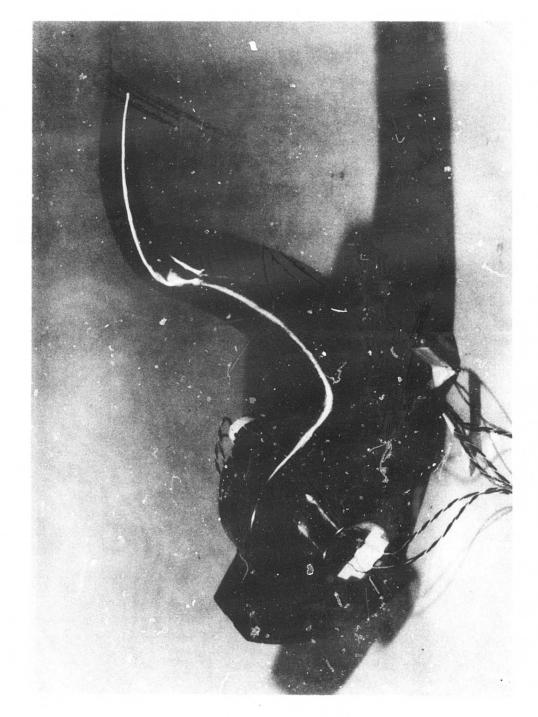
Load Beam Fracture - Second Ultimate Test. Figure 33.

A second beam which incorporated these changes was manufactured and tested. The results were satisfactory, as the beam did not yield under limit load and ultimate failure occurred at 243,500 pounds.
